Warwick Police Department  
Incident Report

Incident #: 22-6887-OF  
Call #: 22-68234

- 1 Traffic Survey- NO PARKING SIGNS PILGRIM PKWY

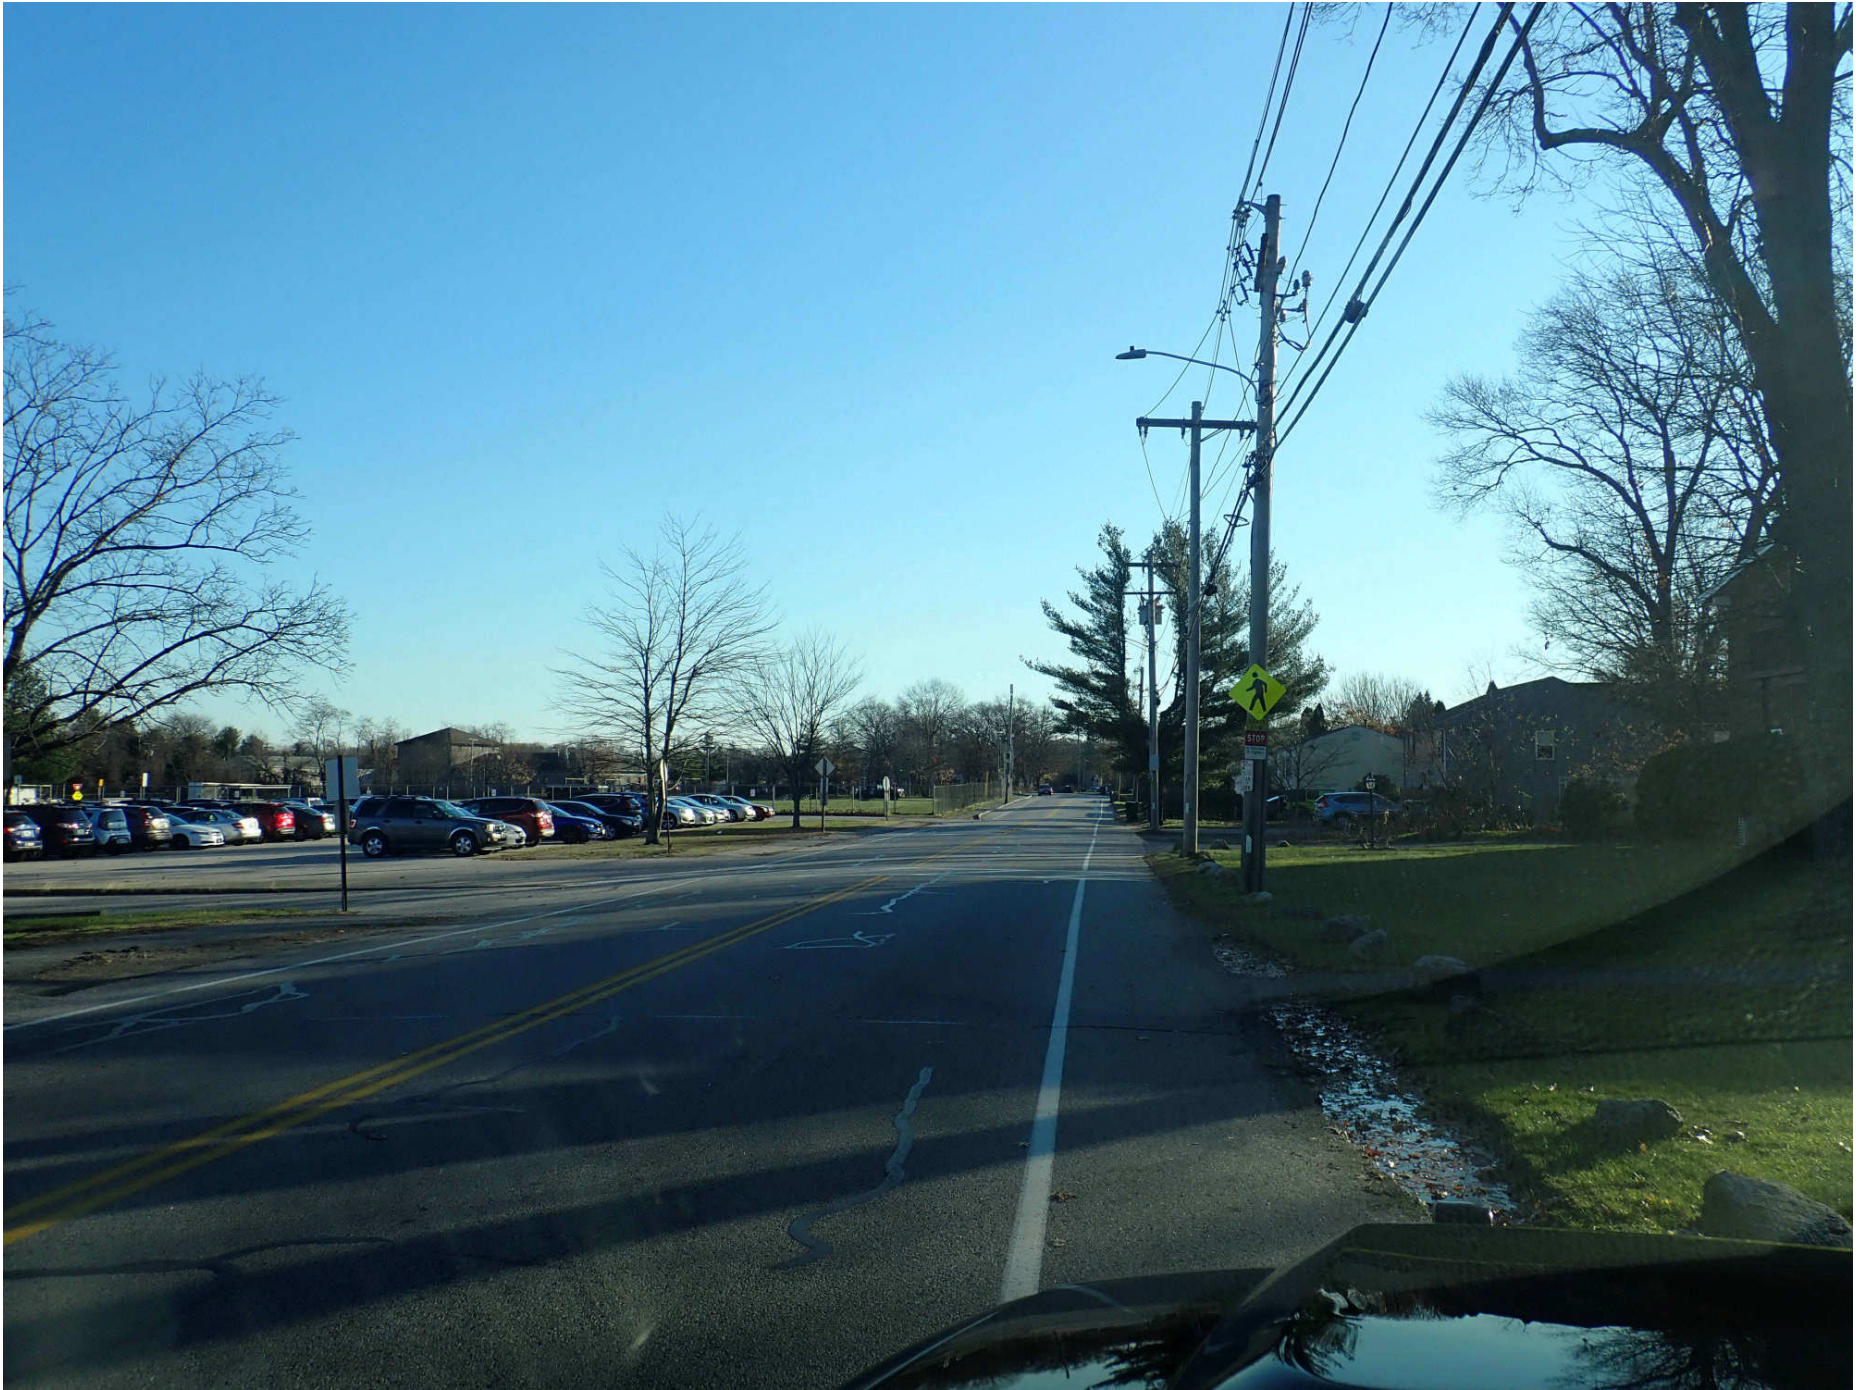
Warwick Police Department  
Image Associated With Case Number 22-6887-OF  
Image Description: EB1

In front of the school there are two painted crosswalks for pedestrians to cross north or south across Pilgrim Parkway. There are yellow diamond crosswalk signs upon approach from the east and west prior to each crosswalk. The crosswalks are there, however, the south side of the roadway does not have any sidewalk. Pedestrians who are forced to walk to school because they are within the walking distance limit have no sidewalk on this side of the road to walk on for safer pedestrian travel (See photos EB1 and EB2).

In conjunction with these No Parking signs being brought forth to the Board of Public Safety to be implemented in our City Ordinance, I also recommend similar curbing to be installed along the sidewalk section in front of the school area that is now lacking any positive divider. East of the school has a simple curbing and directly in front of the school would benefit from this as well to keep vehicles from crossing from the roadway and traveling on the pedestrian sidewalk area. This would help keep the pedestrians safer as they are walking and deter motorists from parking on this stretch of sidewalk. The current sidewalk in place now is in need of repair as well. There are numerous cracks and holes in the pavement that need to be addressed. To offer a more pedestrian friendly and safe walk to school for the students, the south side of Pilgrim Parkway should have a sidewalk with raised curbing as well. At minimum, the sidewalk portion on the south side of Pilgrim Pkwy should extend from Sabin Ave and continue westbound to Fairfax Drive. This will enable any student walking from the neighborhoods south of the school to have a safe walking path as they travel along the southern side of Fairfax Dr toward the crosswalk in front of the school.

- No Parking Both Sides 7A-3P School Days
- Raised curbing along sidewalk edges to separate road and sidewalk
- Sidewalk installed on south side of road for pedestrian traffic

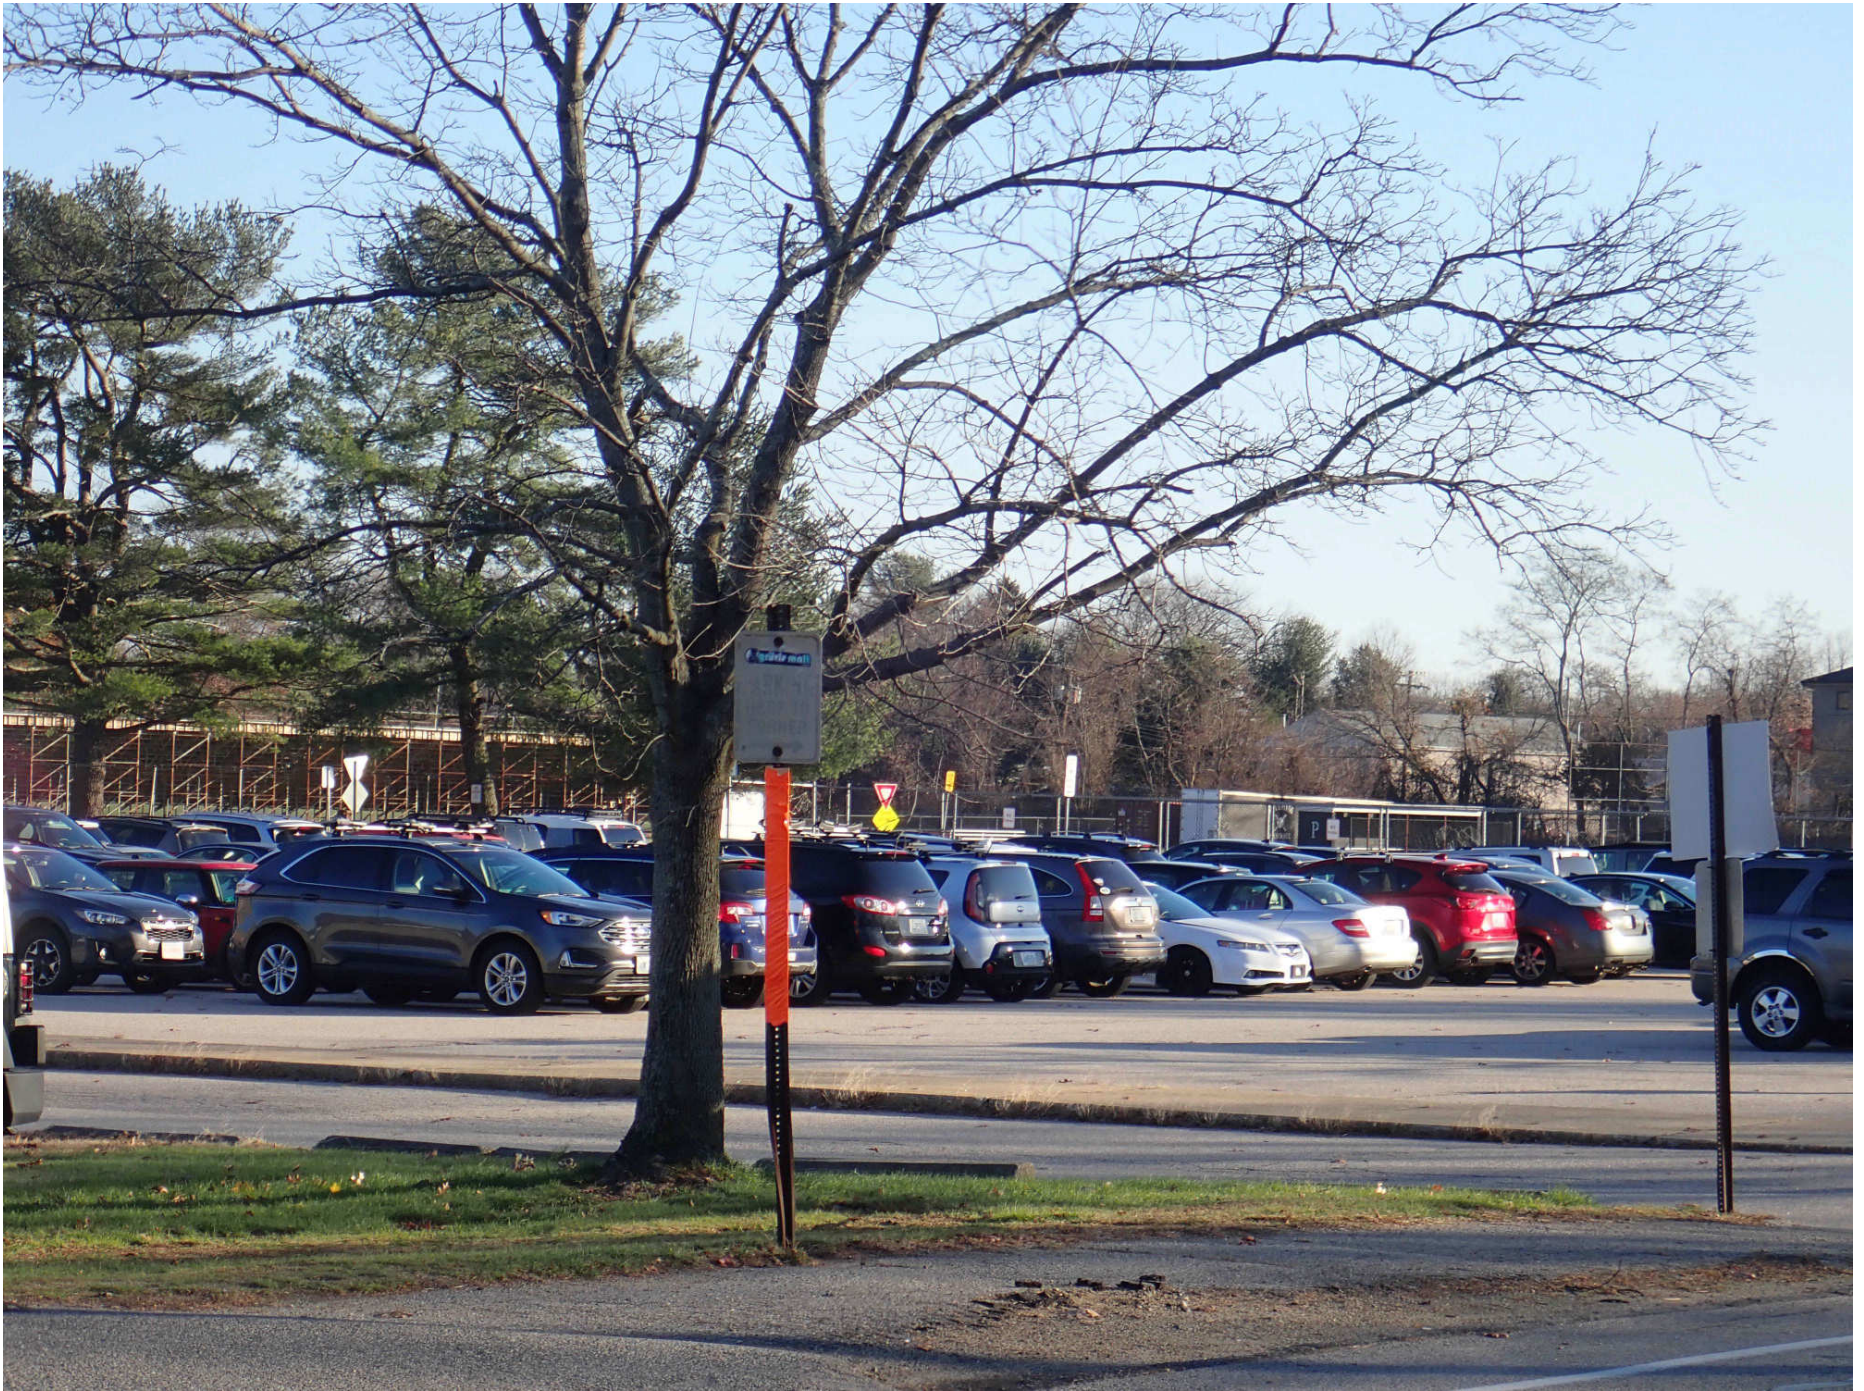
Warwick Police Department  
Image Associated With Case Number 22-6887-OF  
Image Description: SCHOOL FRONT

There is a paved sidewalk located along the northern side (school side) of the roadway along the entire length. The parameters of the sidewalk differentiate as it moves from west to east. The western portion of the sidewalk, located along the front of the school, is paved but it is not raised and there is no curbing at the edge of the roadway before the sidewalk begins (See photos WB4, School Front). In this area, the paved roadway ends and there is a small section of grass/dirt, then the uneven, cracked sidewalk. This lack of curbing easily enables vehicles to pull partially off the roadway and obstruct the sidewalk. The sidewalk east of the school parking lot entrance (starting at the ball field fence) is paved and does have a raised curbing at the edge of the roadway. This curbing separates the edge of the road and the sidewalk, creating a clear walking area for the student pedestrians (See photos WB1, WB2 and WB3). This curbing continues all the way east until you reach the entrance to the Pilgrim Senior Center parking lot where the sidewalk then becomes raised up from the roadway at the height of the curbing.

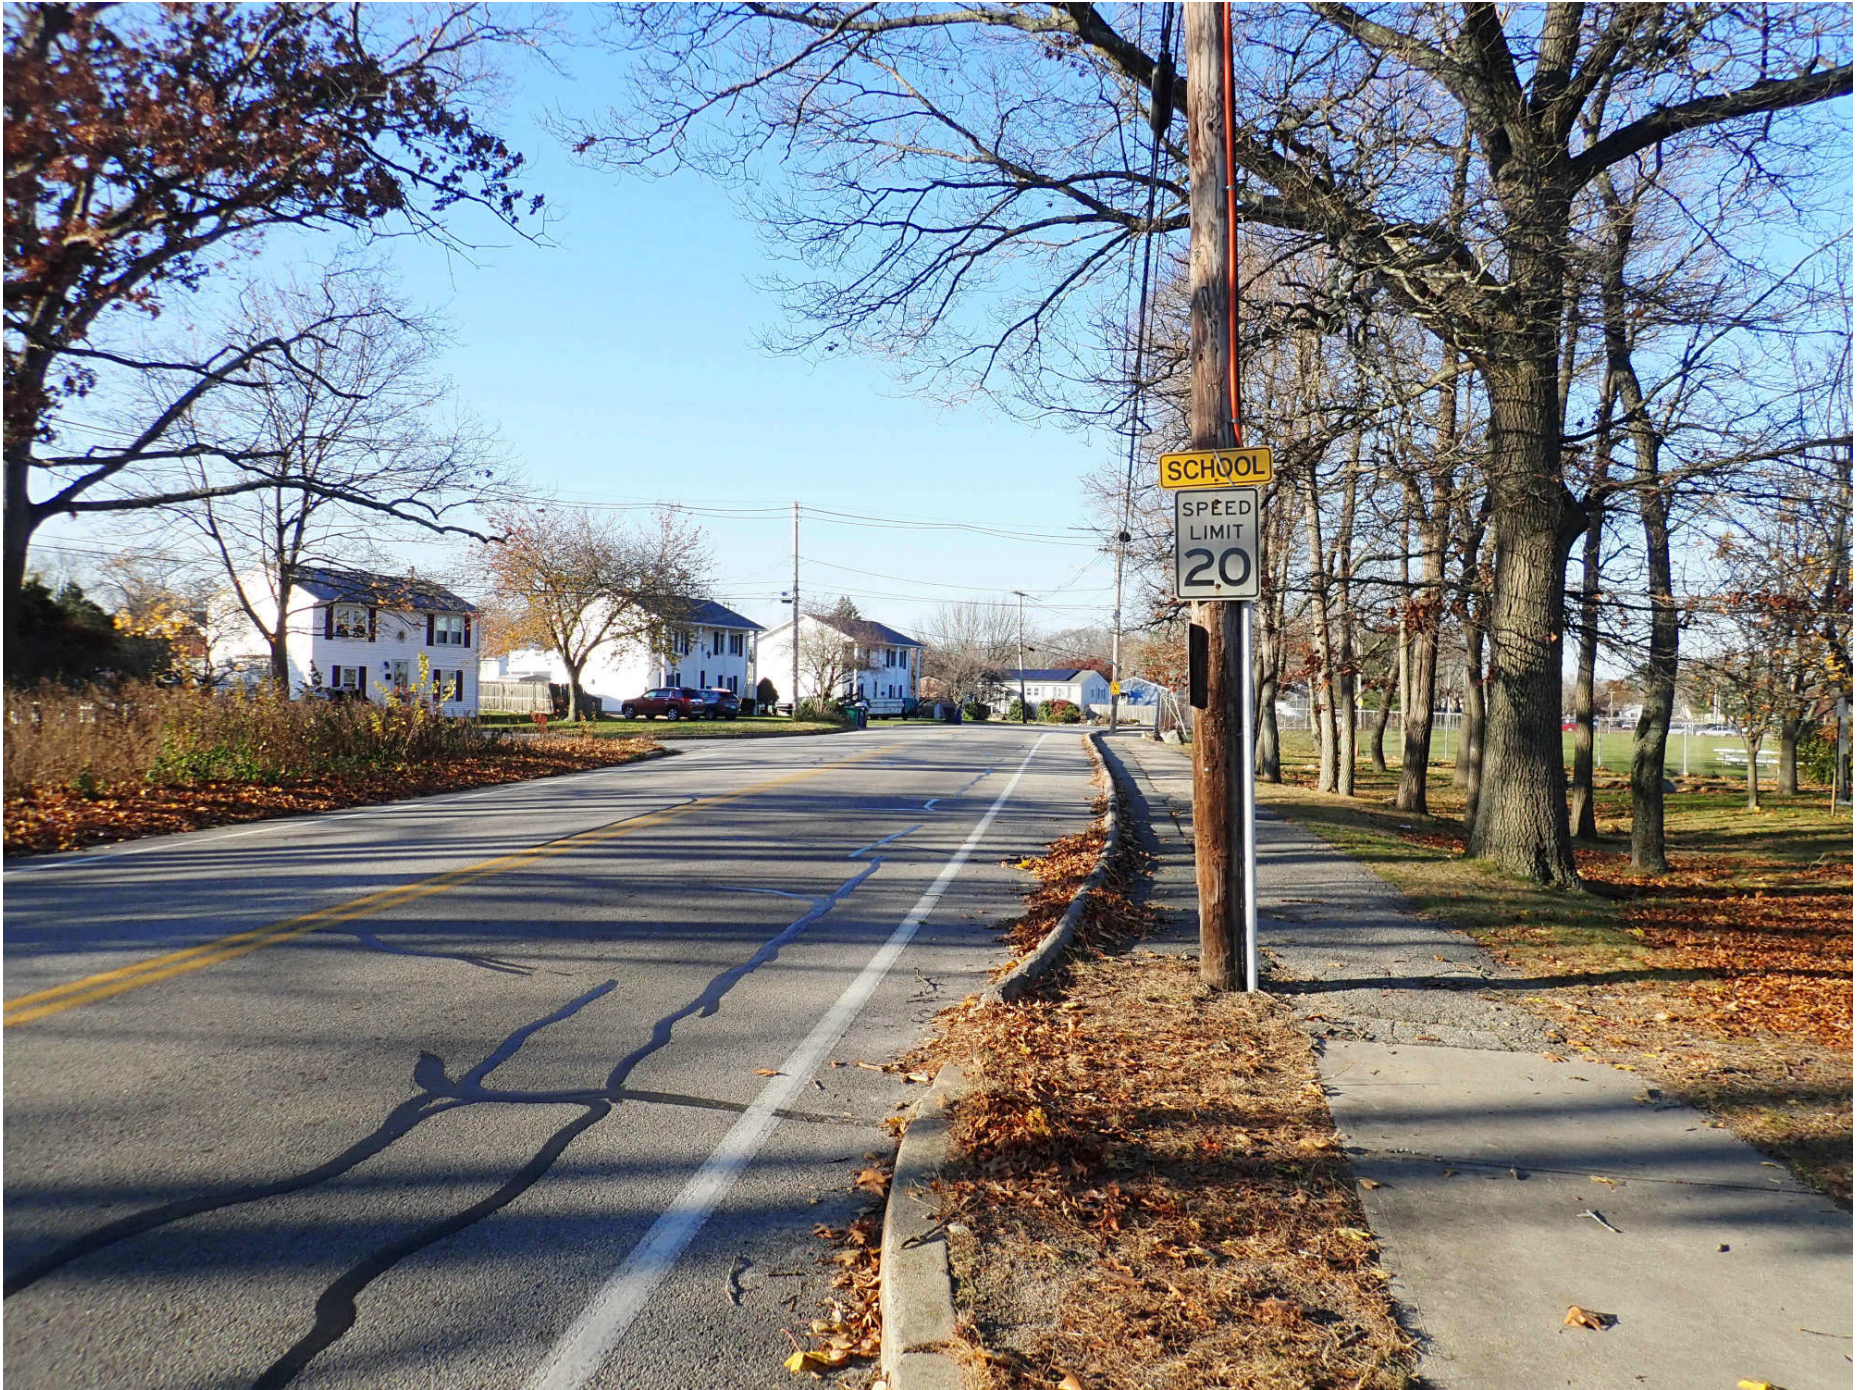
Warwick Police Department  
Image Associated With Case Number 22-6887-OF  
Image Description: WB1

I took photographs and measurements of Pilgrim Parkway along the stretch from Fairfax Drive to just east of Folwer Ave at the western entrance to the Pilgrim Senior Center, 27 Pilgrim Pkwy. The roadway is an east/west road and connects Fairfax Drive to Warwick Avenue. It is two lanes, one eastbound and one westbound, with painted lanes and a double yellow center divider line. It is approximately 32 feet wide with 12 foot travel lanes. This roadway is regularly traveled as it is a cut through from Warwick Ave to Post Rd. Due to Pilgrim High School, this traffic dramatically increases during school drop off and pick up times. Pilgrim High School has a feasible parking and drop off/pick up plan implemented utilizing the large back lot, however, parents are choosing to not follow this plan and park along the heavily traveled roadway causing safety issues and traffic concerns.

Recommendations for a safer school zone on Pilgrim Parkway would be to enact No Parking Both Sides 7A-3P School Days spanning from the Pilgrim Senior Center and continuing west all the way to the intersection of Fairfax Dr. I recommend placing the signs on metal poles on the north side of the road (school side) every 50-75 feet. Along the section of road by the ball field where the chain link fence is installed, the signs can be mounted to the fence the same distance apart. This would ensure that parents view the signs as they drive westbound along the school side of the road prior to stopping.
